**PRELIMINARY INVESTIGATIONS OF
PETROLEUM SPILLAGE ,
HAINES-FAIRBANKS MILITARY PIPELINE, ALASKA**

**Warren E. Rickard
and
Frederick Deneke**

April 1972

**CORPS OF ENGINEERS, U.S. ARMY
COLD REGIONS RESEARCH AND ENGINEERING LABORATORY**

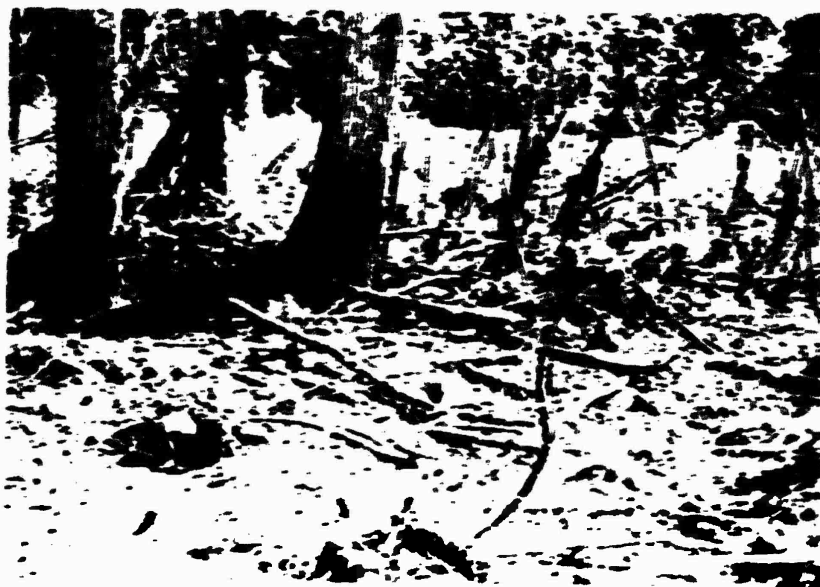
Figure A4. Closeup of interior of the cottonwood stand at MP 17.7 showing some willow and alder growing out from base of original trunk.

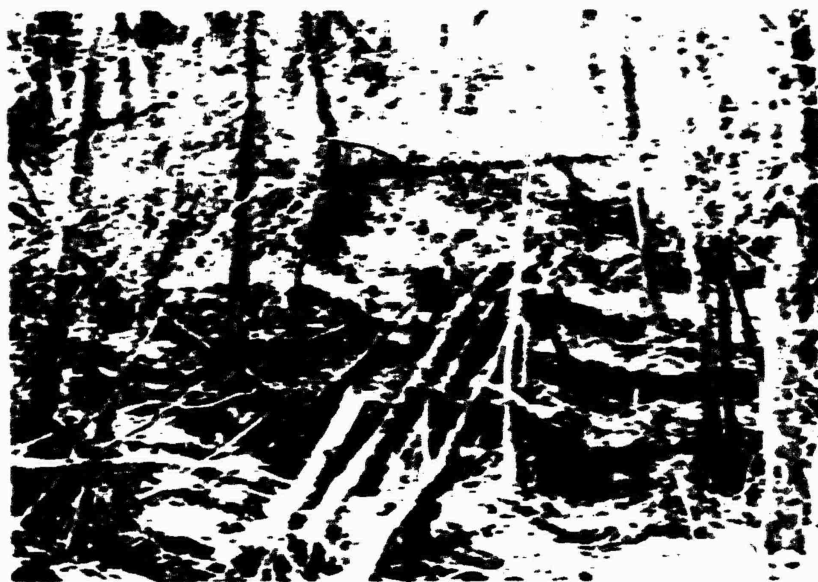
MP 119.1, 17 May 1968. The initial spill area is located some 600-700 feet above the west banks of Dezadeash Lake, Yukon, Canada. This spill is considered by the pipeline personnel to be the most significant in the 15-year history of the pipeline, as an estimated 4000 barrels of diesel fuel were lost. Soils in the area are highly acid and corrosive and caused the weak spot and eventual leak to form in the pipe. Large quantities of fuel permeated down the slope and out into the lake before the leak was located. Strong prevailing winds scattered much fuel along the north shore of the lake five to six miles away. Straw was scattered over the water to absorb the fuel and was then collected and burned. On the slope below the pipe, trenches were dug to collect the fuel as it flowed down the slope. The fuel from the pits was pumped into barrels and burned. A small cleanup party was left at the site for months to clean up any fuel that appeared.

The current investigation revealed that all vegetation in the immediate area of the spill was dead. Some elevated microrelief in the area was apparently above the greatest oil concentration and had some moss cover growing on it. Soil pits at the bottom, middle and top of the slope all had strong odors of petroleum. At least one area was observed where fuel was seeping to the surface. Fishing has apparently returned to near normal on the lake since the significant fish kill reported at the time of the spill.

Figure A6. A partial view of kill area at MP 119.1.

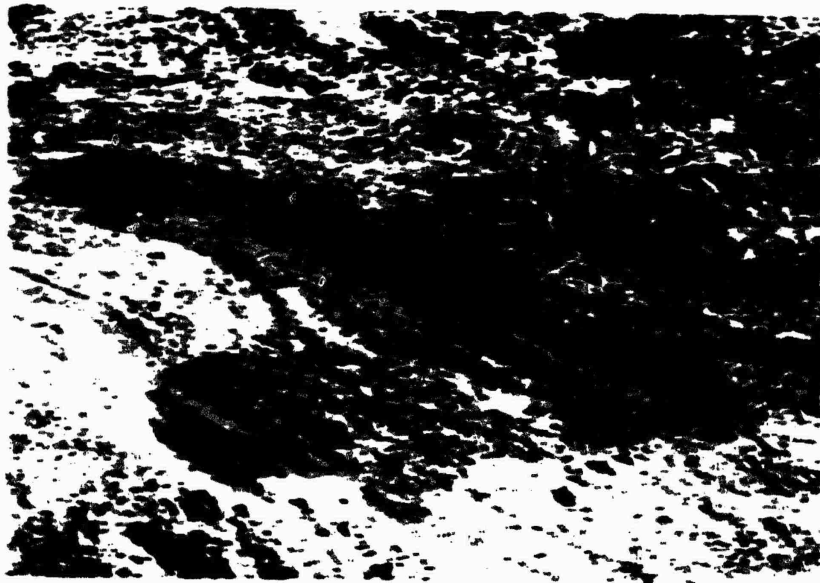
Figure A9. Fuel seepage on the surface of an access trail through the spill area at MP 119.1.

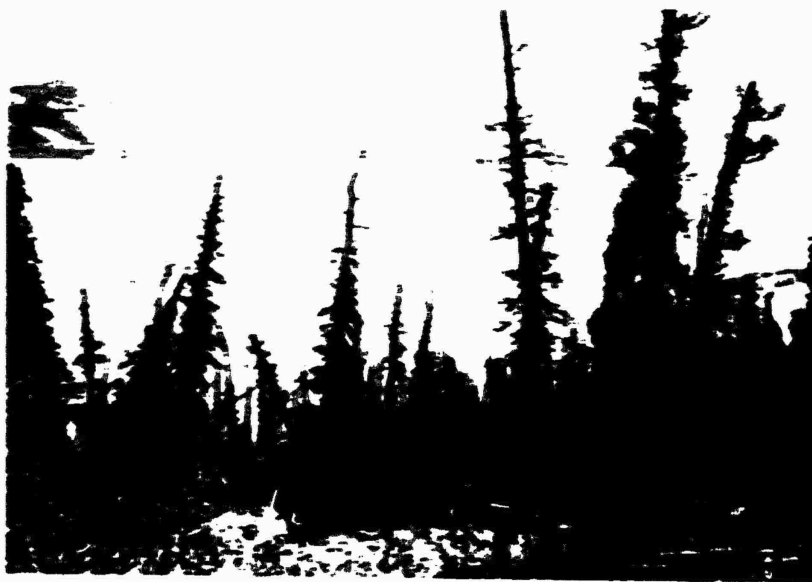
MP 197.1, 30 January 1956. This area is on a north- to northeast-facing steep slope with the pipe nearly ¼ mile from the bottom of the slope. The fuel was allowed to run down the slope when the line was cut for purging. All species of vegetation were killed at the time of the spill. Some grass is growing in an old Cat trail that traverses the area but very little other new vegetation is evident. A few small white spruce 6 to 12 inches tall are growing at scattered locations within the area. There is at least one area where the surface organic mat has been washed away leaving a small depression 10 to 12 feet in diameter. Other visible evidence of slope movement is present as 2- to 4-inch cracks which can be seen where the organic mat has pulled apart. Strong petroleum odors were found in all three soil pits placed on the slope. Some hummocks have moss and Labrador tea growing on them within the area. The lower portion of the slope has been cleared for construction of a telephone line and several small white spruce are growing there.

Figure A10. Overall view at MP 197.1 looking downslope during a 1956 spill.

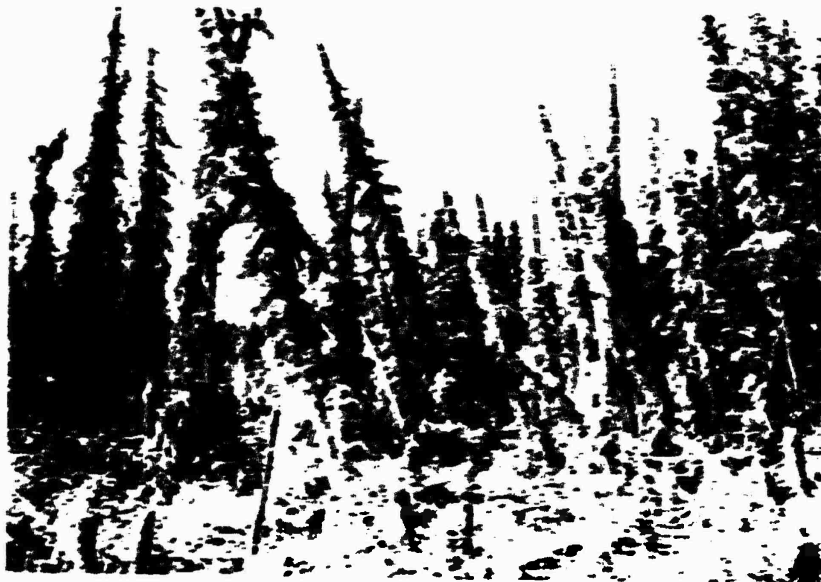
Figure A12. Looking upslope at MP 197.1 into kill area. Small spruce are growing in the cleared area at the base of the slope.

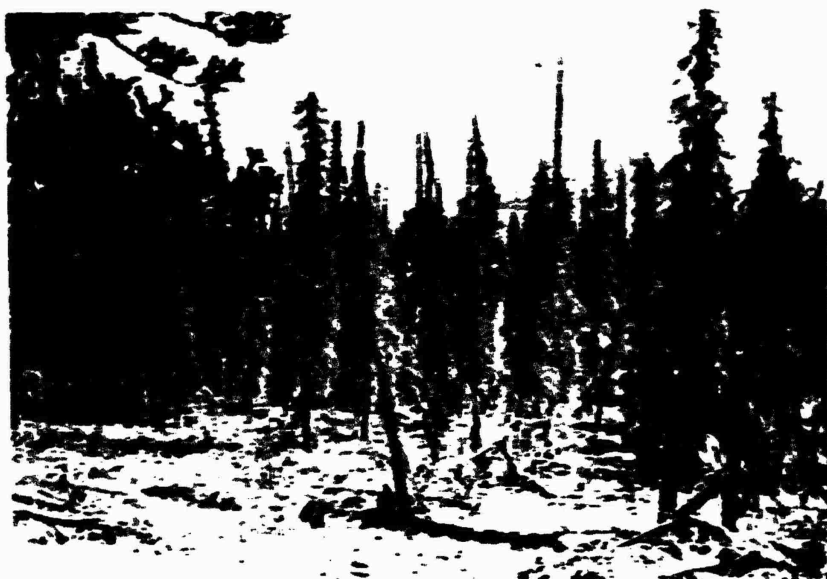
MP 207.6, 2 February 1956. This is a large area 200 feet wide near the pipe and forms an inverted V-shape 700-800 feet down a gentle slope. The area could be called a small watershed basin. Vegetation is completely lacking in the center of the main spill area. Three soil pits were placed in the kill area and on the fringe. Odors of petroleum were present in all three with the soil frozen at 20 cm.

Figure A13. View of 1936 line cuts at MP 207.6.

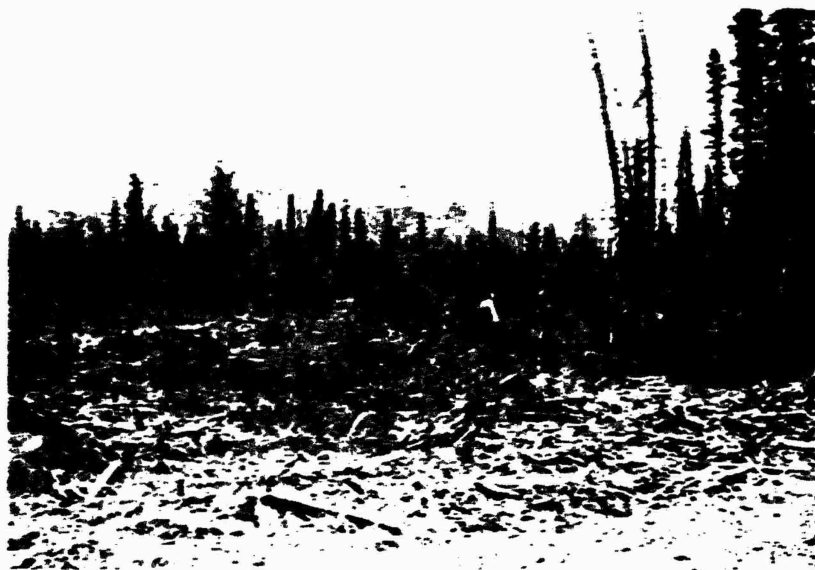
MP 217.1, 9 February 1956. Spillage here was over an area 100 feet wide and 300 feet long on a very gentle slope. The soil appears to be very well drained. A fire had apparently covered the entire area prior to the spill as many fallen spruce were present. Areas outside the spill have good spruce and moss growth. Within the spill area a number of small spruce, labrador tea and other plants are growing. Of all the 1956 spill sites this one had the most abundant amount of vegetation.

Figure A16. A line cut at MP 217.1 during 1956 retarded new growth in an area burned prior to the fuel spill.

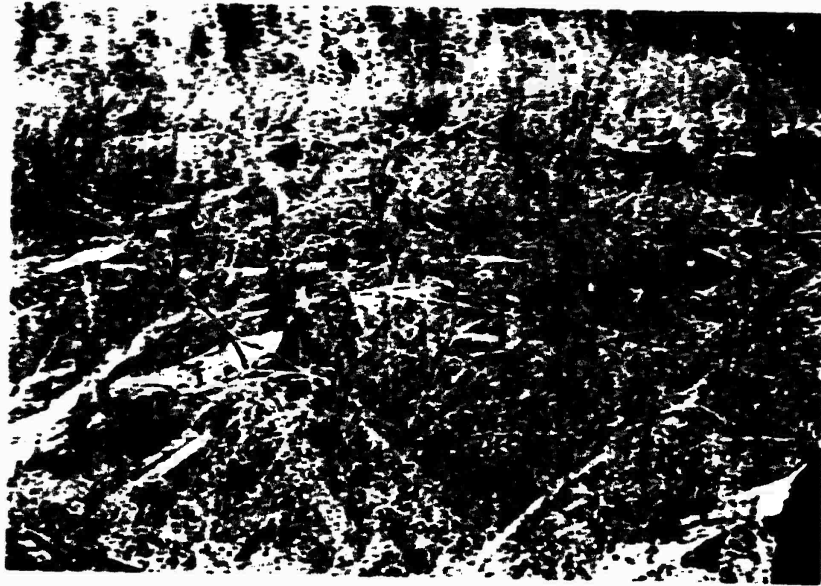
Figure A17. The interior of the MP 217.1 spill is covered with considerable recent growth.

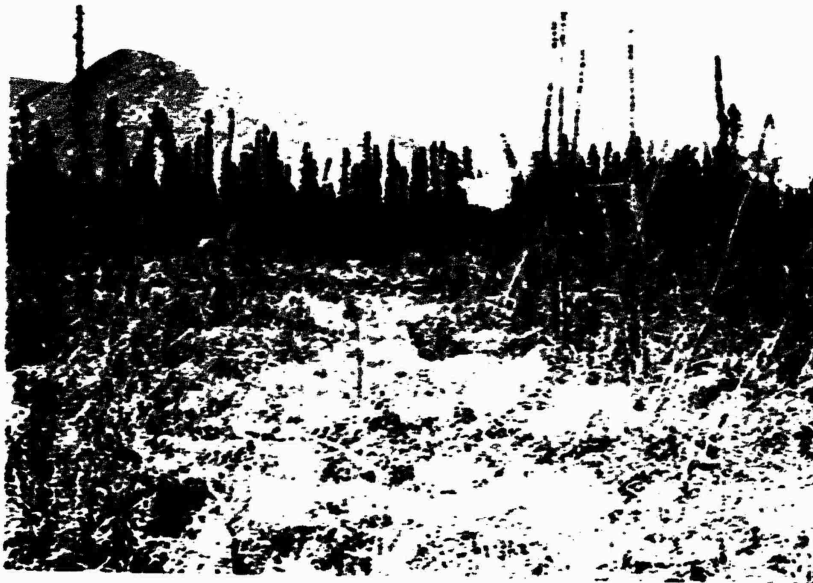
MP 273.2, 29 February 1956. This is a rather large spill area at least 250 feet in diameter. The pipe was purged into a small drainage area on the 1-2° slope. All vegetation, of which black spruce predominates, was apparently killed at the time. The main drainage area now has vegetation growing in it. However, in those areas not directly in the drainage basin no vegetation has yet become established. A soil pit was placed in both living and dead areas.

Figure A18. A spill at 273.2 has little new growth except in the drainage basin that traverses the area.

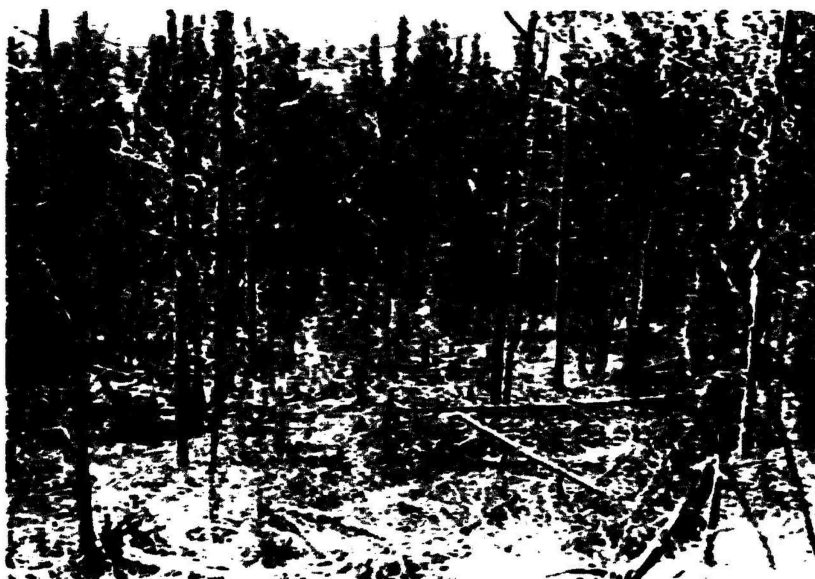
MP 382.5, 16 March 1956. Fuel spilled at this location was gasoline, called Mo Gas by the Petroleum Distribution Office. The site is on a very steep 40° south-facing slope. Soil is a well drained silt loam and contains a layer of fine volcanic ash. The spill killed aspen 4 to 6 inches in diameter and all the surface cover. Brumus, small aspen, fireweed and bearberry are growing at scattered locations within the area. Soil pits from mid-slope gave a strong odor of gasoline.

Figure A19. Downslope view of area at MP 382.5.

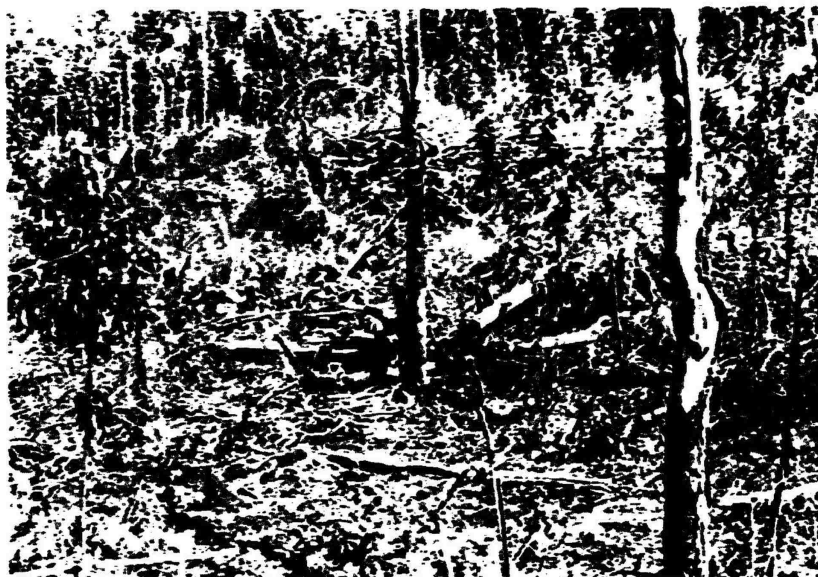
Figure A20. Side view at edge of MP 382.5 spill with dead aspen in foreground.

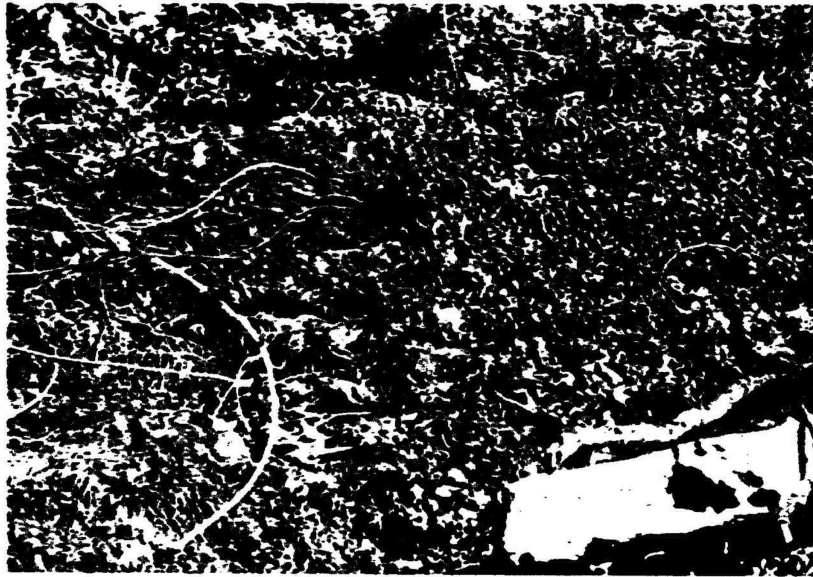
Figure A21. Close up of bearberry at MP 382.5 growing at edge of spill area to left of photo.
